# Spark Plug Warranty Pre-Check Sheet

Version: 2.0 / Date: January 2026

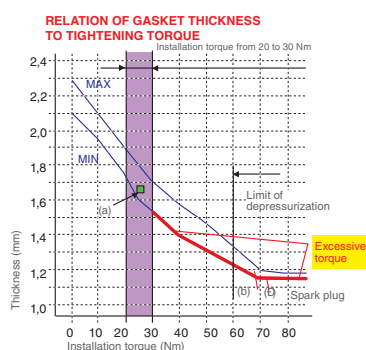
- Spark Plugs with rotating insulator were over tightened, which is concluded from too small thickness of gasket
- To avoid such effect DENSO recommends to apply correct tightening torque

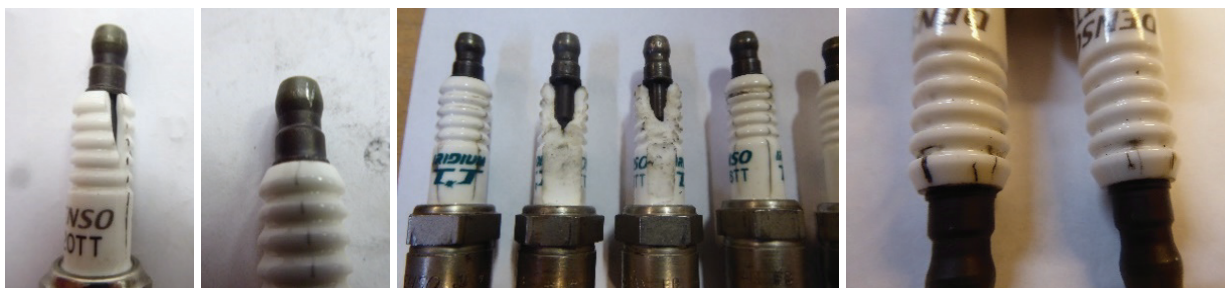
Is the spark plug damaged on the outside  
(cracked ceramic / bended terminal / damaged ( hexagon)

- \* Damage to the spark plug will greatly affect the performance of the part

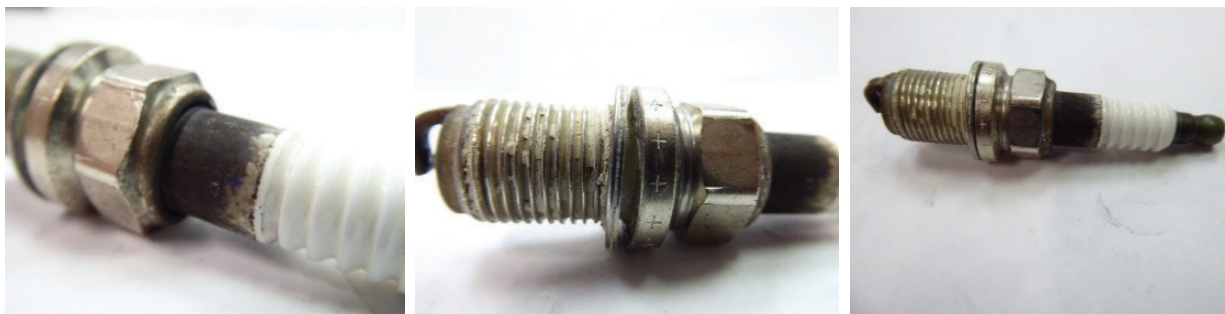
When the insulator is loose --> exhaust gasses leak through the housing (internal leakage).  
Root cause is over-torque at installation. Apart from a loose insulator, you will see a fully compressed gasket that confirms over torque.

- \* When the insulator is loose there will be no performance of the spark plug

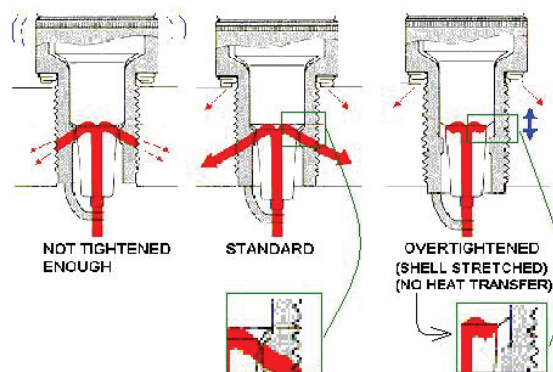
The thickness of the gasket must be between 1.8mm and 1.3mm

If the gasket is over 1.8mm the spark plug was installed with less torque that can cause vibration and possible combustion leakage

A gasket thickness below 1.3 mm indicates over tightening, which causes the a stretched metal housing which leads to over heating.

\* When the gasket is fully compressed there will be overheating problems that will cause misfires and bad performance of the spark plug
